## Pre-Purchase Inspection Report

**1972 Chevrolet C10 • Paris, Kentucky • Inspected September 8, 2026**

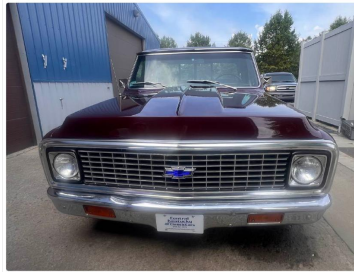
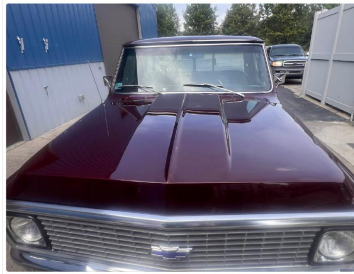
- Aftermarket hood sits close on the driver side and open on the passenger side — typical of a replacement cowl hood, not a wreck clue by itself.
- Doors sit slightly low; light rub at the front of both rockers where the door bottoms meet the cab.

Front 3/4 and cowl hood — aftermarket hood fit called out in notes.

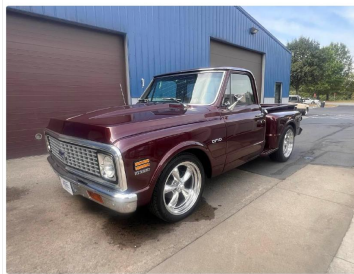
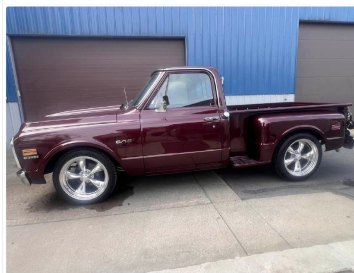
Street-side and 3/4 views used to document overall presentation.

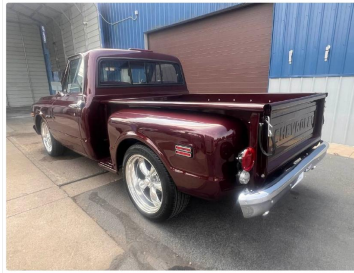
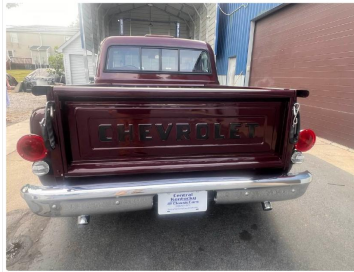
6/76

Rear and tailgate. Bed wood and chrome strips documented in the full set.

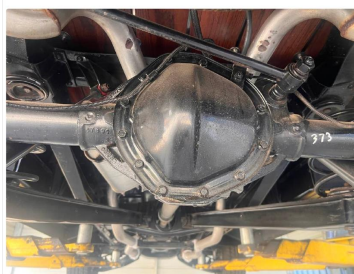
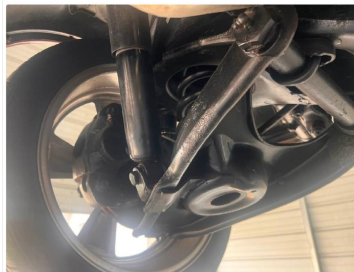
70/76

Underbody example: rear axle / suspension. Full report has additional frame, floor, and leak photos.
